Improving Voice & Data Network Reliability and Reducing Service Costs

Benefits from an Enhanced Reliability Modular Connection Block

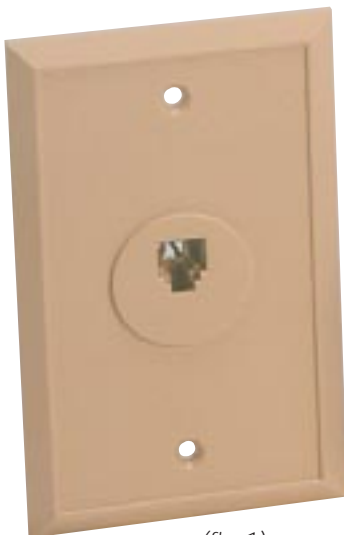
Today's standard modular connecting block (fig 1) offers little protection from contamination. Although the plastic housing blocks the majority of everyday contaminants, hidden contaminants such as moisture create a treacherous environment for fostering corrosion. Contamination can occur from all directions, attacking cables, and connector cavities from outside the wall as well as inside.

Contamination can occur from all directions, attacking cables, and connector cavities from outside the wall as well as inside.

Noisy lines, slow connection speeds, and service outages are often due to the effects of corrosion. Within a home or business, voice and data networks have several potential failure points in which corrosion related problems could occur. The most common failure point is the modular connecting block (fig. 1) where a voice or data device cord connects with the internal wiring infrastructure. Industry experts conservatively estimate that 5-10% of access lines in a given year are serviced to resolve issues involving corrosion. This percentage is significantly higher in regions more prone to contamination and corrosion. BellSouth alone identified over 240,000 dispatches/year attributed to failed modular connecting blocks.²

Inside the modular connecting block, the base spring-wire is a combination of nickel and brass or bronze, plated with gold to protect the base material, and crimp-connected to a copper lead wire. When dissimilar metals are exposed to moisture, galvanic action and corrosion can occur in as little as one week. Corrosion causes the gold plating to rupture, which accelerates the corrosion process. During corrosion, the connectors develop low insulation resistance and decreased dielectric breakdown voltage. This will impact the dial tone service, network connection speed and signal integrity. Once corrosion begins on the connection, it can wick down the insulation and into the jack. Ordinary station cable can wick moisture at rates of up to 1-foot per day, leading to greater replacement costs.

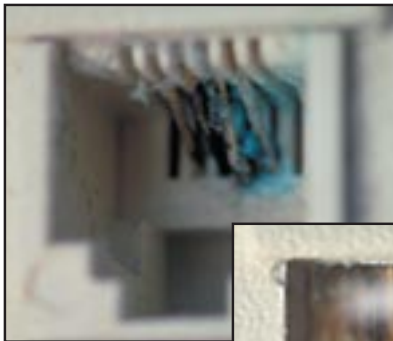
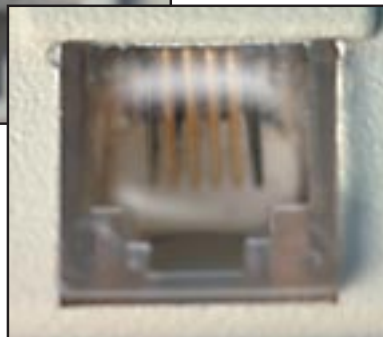
(fig. 2)

a cross polymer gel developed by Raychem (now a division of Tyco Electronics).

Originally designed for its sealed outside-plant (cabling) products, *GelGuard* was ideal for a corrosion protection application.

In 1992, BellSouth became active in finding a solution to battle the significant expenses generated by corrosion related failures to modular connecting blocks. BellSouth partnered with Bellcore, the research and testing group that defines industry specifications, and began to search for a non-toxic substance that would remain in the modular connecting block after the removal of the connecting plug. The search led them to *GelGuard™*,

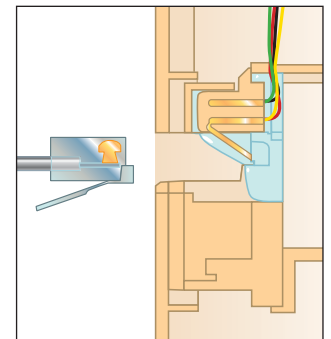
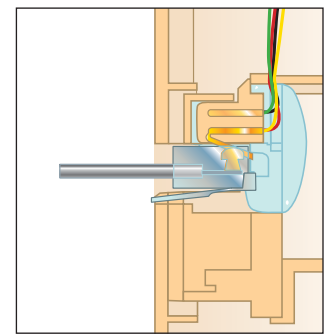
(fig. 3)

Prior to plug insertion, the *CorroShield* gel maintains an airtight seal around all conducting surfaces in the jack.

The gel is displaced upon plug insertion, resulting in a protective airtight seal around the plug and jack conducting surfaces.

inserted (fig. 3), the gel displaces and forms an airtight seal around the connection, preventing corrosion and other contact problems.

The *CorroShield* products utilize the specially formulated *GelGuard* which is applied during manufacturing to all surfaces at risk of contamination, completely surrounding the gold contact wires. When the voice or data cord is

One of the attributes critical to the design and performance of the *CorroShield* solution is the memory characteristics of the gel. For years, attempts to protect connecting blocks from corrosion would prompt service providers to apply grease to the conductors. The shortcoming of this solution would materialize when a customer would unplug a device, re-exposing the conductors to environmental contaminants. The unique memory characteristics of the *CorroShield* gel return it to its original position after a plug is removed, maintaining the airtight seal. Competing products have been introduced into the market, but the inability of the gel to remain pliable and stay in the connecting block limits the effective life of the product. *CorroShield* products have been developed and tested to deliver hundreds of reinsertion events for continued protection in a high service environment.

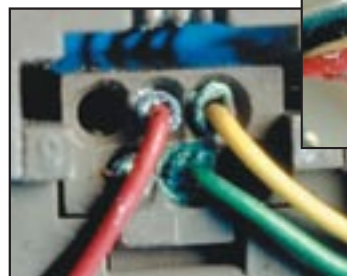
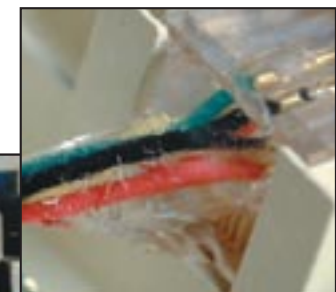
CorroShield protects all conducting surfaces (fig. 4)

Contamination can occur from all directions and in some applications the space behind the connector cavity can be the most vulnerable. In addition to protecting the connector cavity, many *CorroShield* products feature an extra level of protection immediately behind the cavity by sealing the entire cavity in a protective plastic shell. To prevent screw terminal corrosion, *CorroShield* is also available with filled Scotchlok™ connectors from 3M. For technicians, this means no more time consumed backing off screw terminals, stripping and landing the wires, and re-tightening the screws. With the Scotchlok™ connectors, the wire is simply inserted complete with insulation and squeezed for a gas-tight termination and maximum protection. The *CorroShield* product line has also been extended to connection cords, which have the *GelGuard* injected into the plug ends, right where the line cord and the plug wires are spliced together.

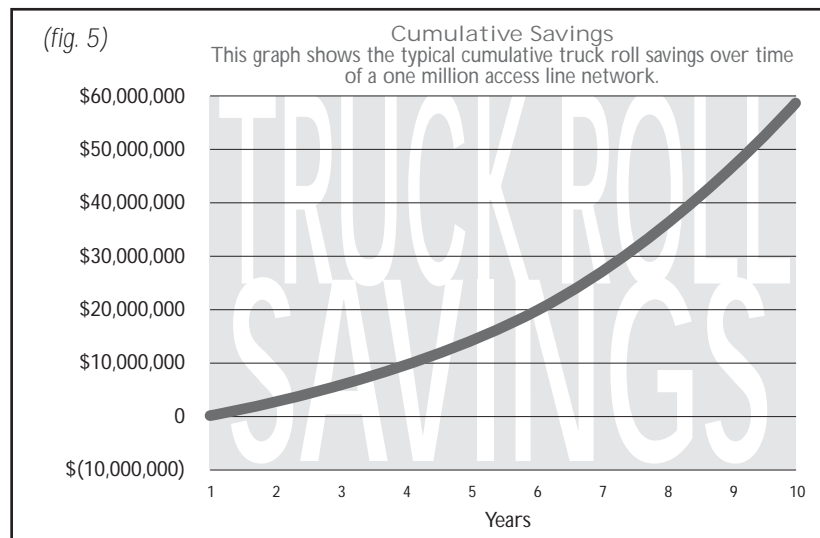
Saving time and money exhausted in service calls is why *CorroShield* was created. Service Providers have found that its use will result in a 5-10% reduction in corrosion service calls each year, leading to significant savings. BellSouth has encountered a reduction in modular block failures of approximately 330,000 over the first two years of use, equating to roughly \$33 million in savings.⁵ PacBell also noted an average cost savings of \$80,000 per month after beginning to use *CorroShield*.⁶ Figure 5

shows that over time this can add up to tens of millions of dollars in savings.
